### Model: SE-4000 Firmware Release Info

Mar. 12, 2026

#### Firmware Versions

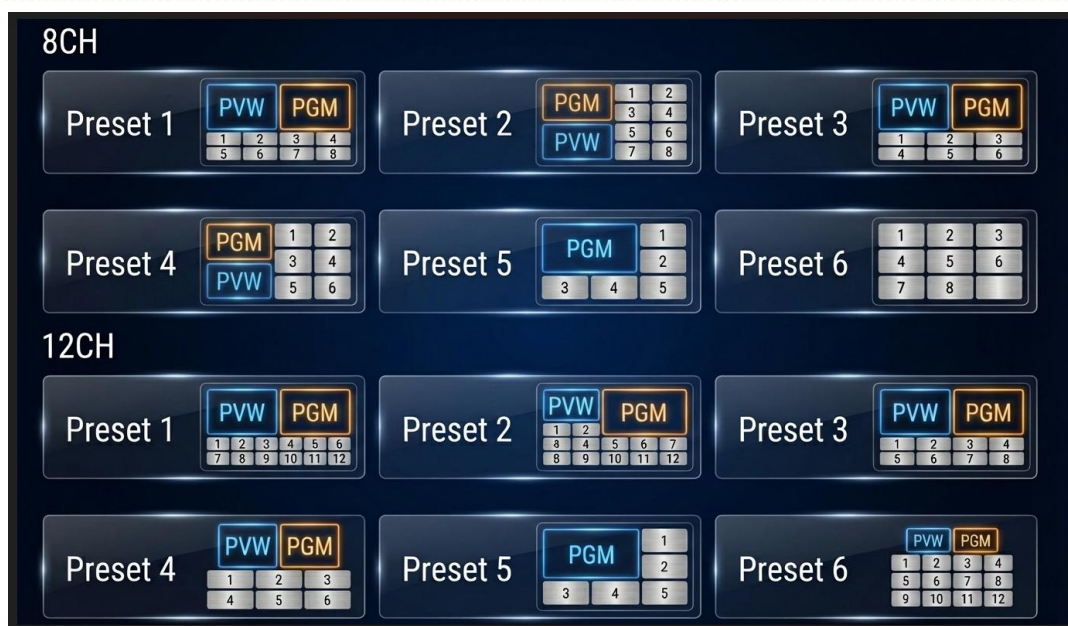
5. Modified MV Presets 1-6 to allow a maximum of 8 or 12 inputs for each Preview.
